**AUTOMATED LONGWALL GUIDANCE AND CONTROL
VERTICAL CONTROL SUBSYSTEM**

VOLUME I

W.R. Griffiths, M. Smirlock, J. Aplin,
R. Fish, D. Fish
Foster-Miller Associates, Inc.

January 1982

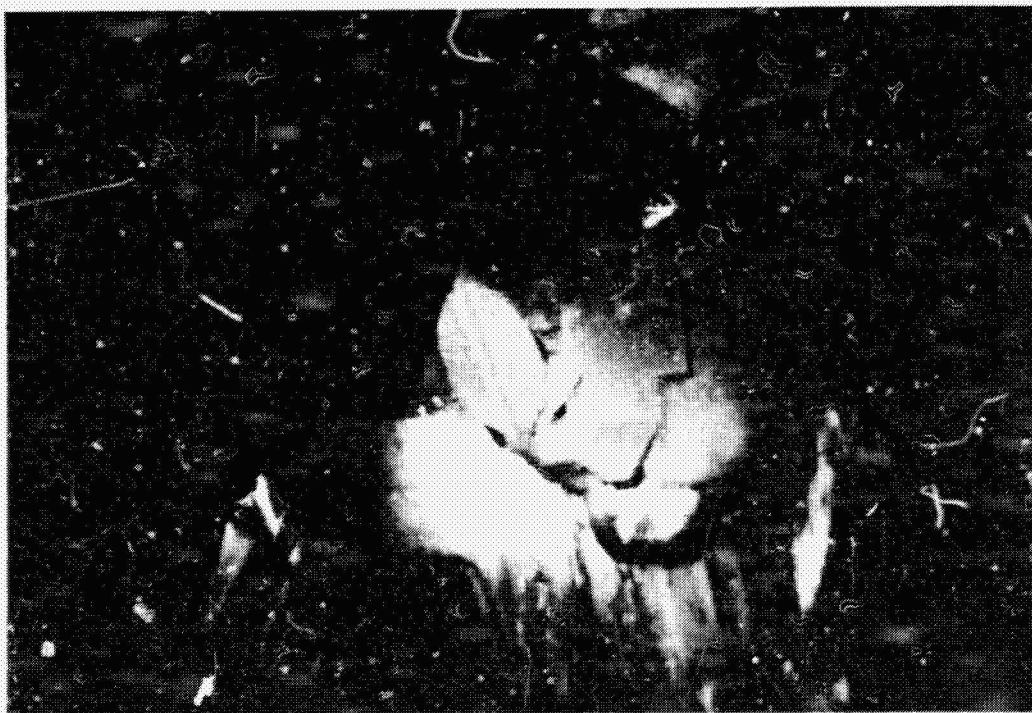
Figure 65. - First LCF mount modification.
